Investigation of Steel-Stringer Bridges: Superstructures and Substructures, Volume II

Final Report
October 2007

Sponsored by
the Iowa Highway Research Board (Project TR-522)
and the Iowa Department of Transportation (CTRE Project 04-184).

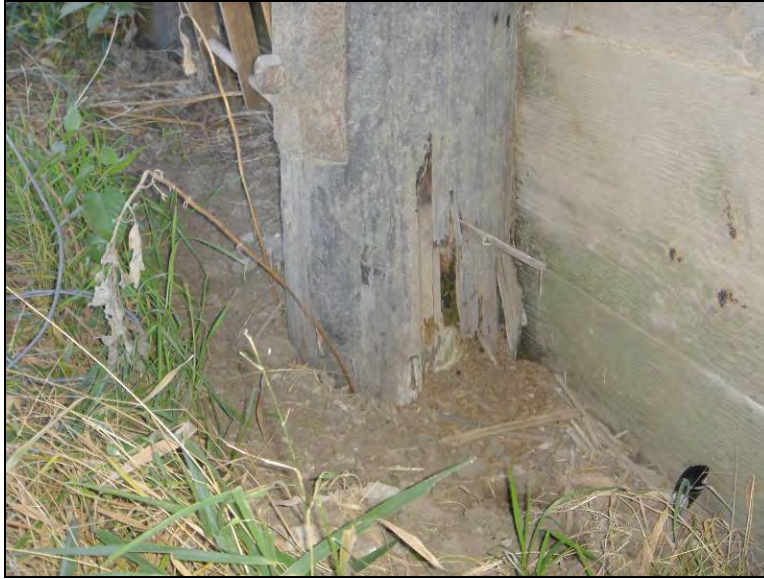
The south abutment, shown in Figure 9.6, has an average exposed pile length of about 94 inches and an average pile spacing of 49 inches. The tie back rods are about 6.5 ft from the pile heads. Figure 9.7 is a schematic diagram of the south abutment illustrating the exposed pile lengths and spacing. Visual observation revealed brooming in pile no. 2 near the ground level as shown in Figure 9.8. For pile no. 5, rotting near the ground level was observed (See Figure 9.9).

Figure 9.8. Brooming of pile No. 2 near the ground level (Bridge No. 237350 Mahaska County – October 25 2005)

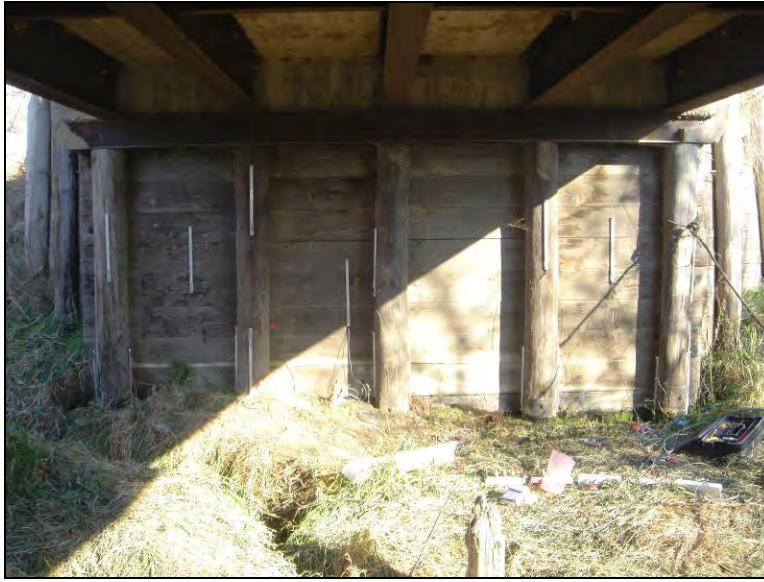
Figure 9.10. Substructure instrumentation (Bridge No. 237350 Mahaska County – October 28 2005)

A static load test was performed at the north and south abutments where three loading increments were applied. Each pile was instrumented with three strain transducers with a gage length equal to 24 inches. Each timber backwall was also instrumented with three strain transducers with 24 inches gage lengths (See Figure 9.10). The soil was excavated around pile nos. 1 and 5 at the north and south abutments, respectively, to allow for installation of the strain transducer across the biologically deteriorated region (See Figure 9.11).

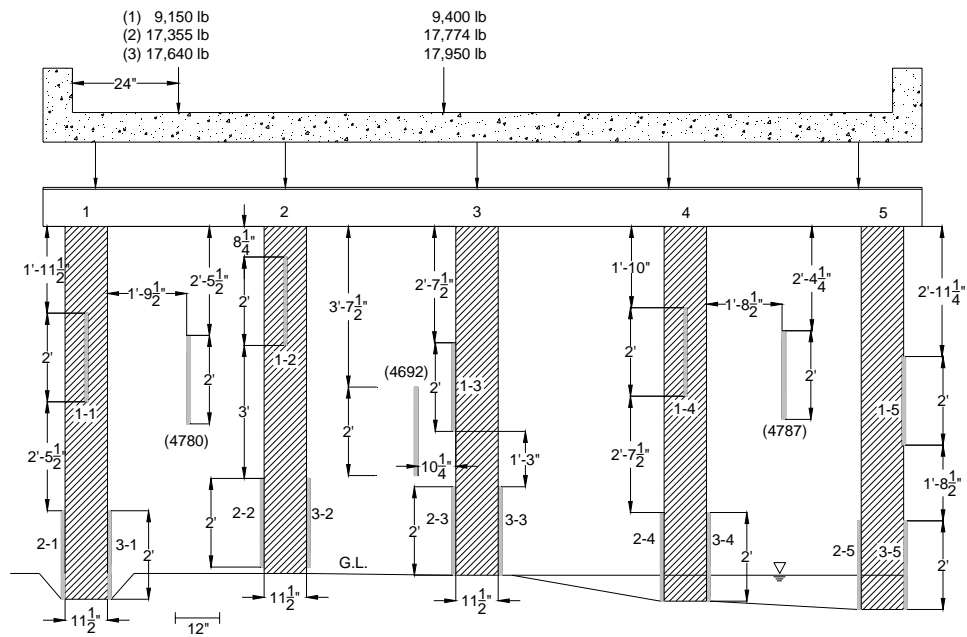
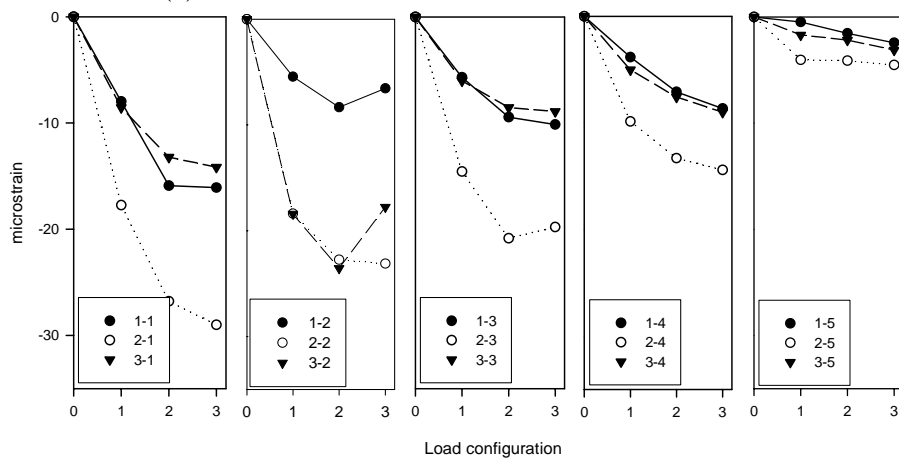
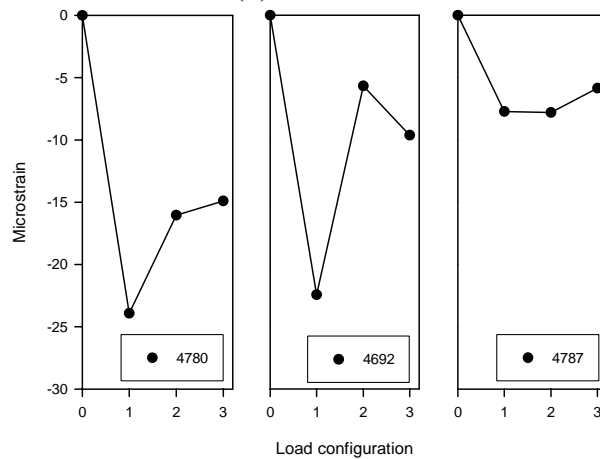
Figure 9.12. Static load test at the west edge (Bridge No. 237350 – Mahaska County)

The first load test was performed with the load at the west edge of the bridge. The load was offset about 2 ft from the curb. Figure 9.12 shows the location and magnitude of the loads, pile strains, and backwall strains. The highest strain measured was in pile no. 1 and was about -29 microstrains during load configuration 3. The measured strain decreased with increasing distance from the location of the applied loads. Strain transducer 2-1, which was attached to a biologically deteriorated section, indicated a higher strain measurement when compared to other strain measurements in pile no. 1.

The backwall strains were highest near the applied load, and decreased with increasing distance from the location of the loads. For load configurations 2 and 3, the recorded strain decreased due to reduction in axial load. Negative strains were recorded at load configuration 3 because of the partial bearing of the pile cap on the backwall (See Figure 9.13).

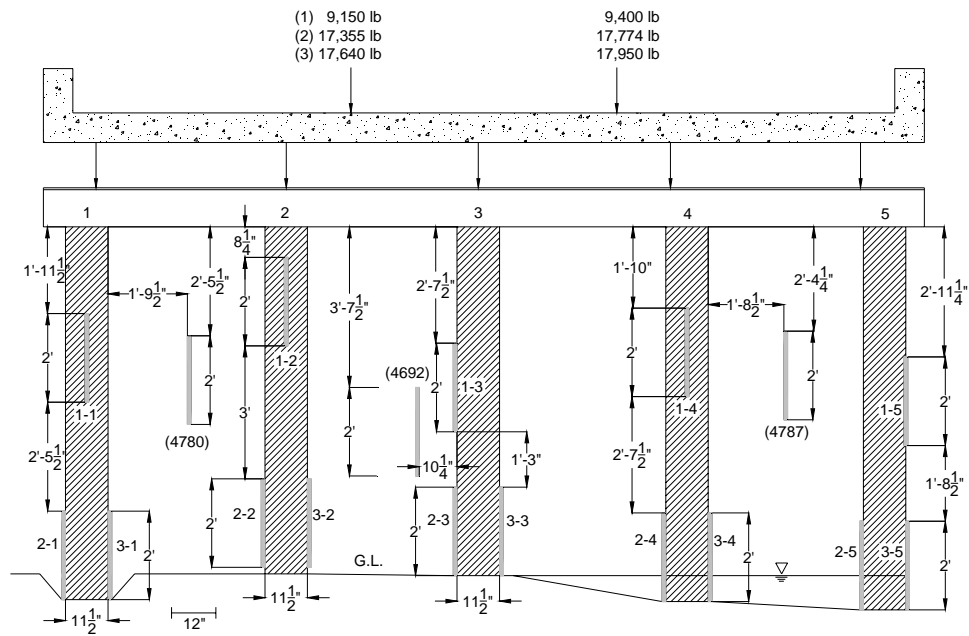
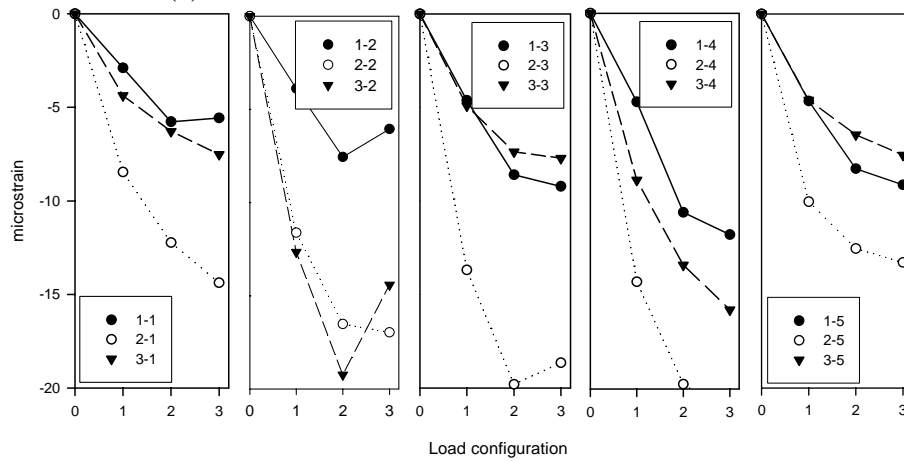
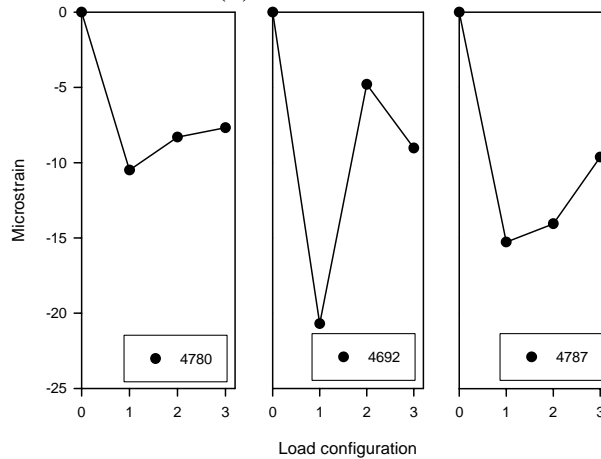
Figure 9.14. Static load test at the centerline (Bridge No. 237350 – Mahaska County)

The second load test was performed with the load in the centerline lane. The location and magnitude of the applied axial loads, pile strains, and backwall strains are shown in Figure 9.14. The recorded strains were highest in pile nos. 2, 3, and 4 and decreased with increasing distance from the location of the applied load. The highest strain occurred in pile no. 4 and was about -20 microstrains in load configuration 3. Strain transducer 2-1 continued to show higher strain compared to other strains measured in pile no. 1. Similarly, the backwall strains were highest directly under the applied load (i.e. between pile nos. 2 and 3). In load configuration 1, the highest strain measured was about -21 microstrains between pile nos. 2 and 3.

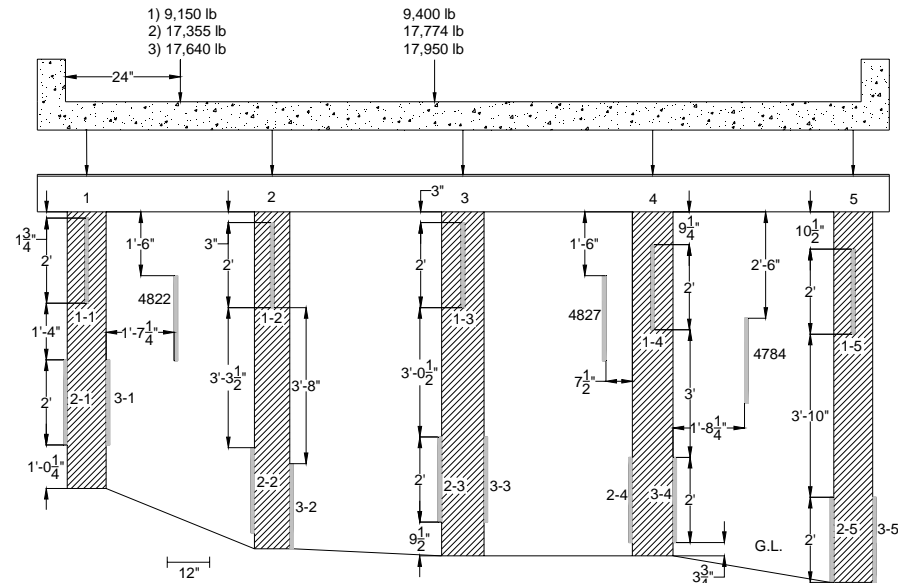
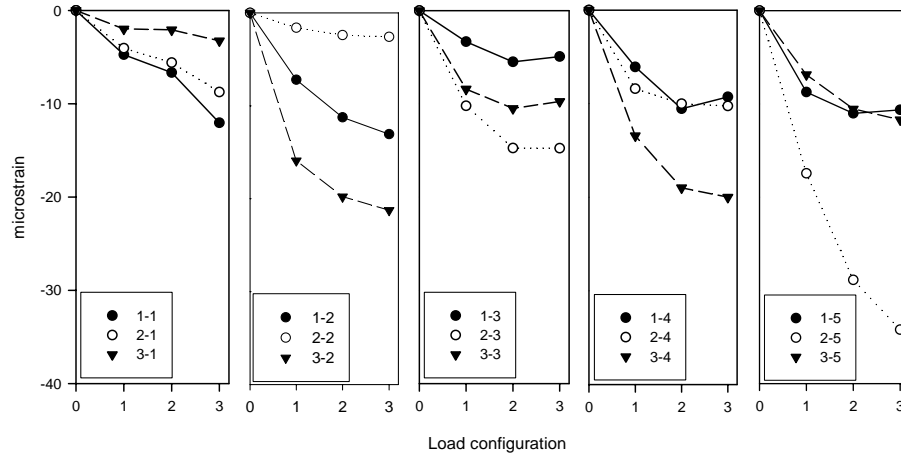
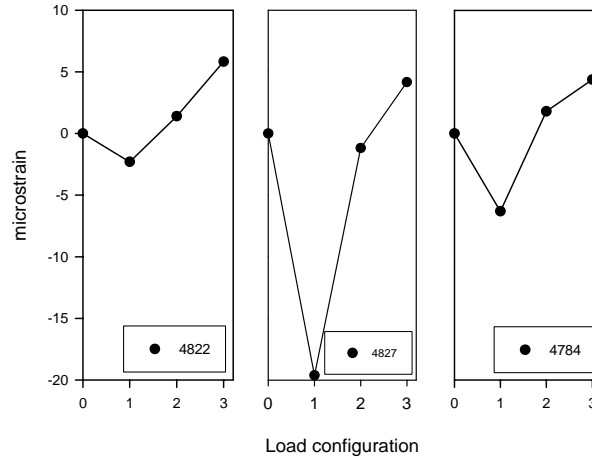
Figure 9.16. Static load test at the west edge (Bridge No. 237350 – Mahaska County)

At the south abutment, the first static load test was performed with the load at the west edge of the bridge. The load was offset about 2 ft from the curb. The location and magnitude of the applied axial loads, piles strains, and backwall strains are presented in Figure 9.16. The highest strain was measured in pile no. 5 and was about -34 microstrains at load configuration 3. The measured strain decreased with increasing distance from the location of the applied loads. Strain transducers 3-2 and 2-5, which were attached to soft sections near the ground level, displayed higher strains compared to other strain measurements in pile nos. 2 and 5.

The highest backwall strain was between pile nos. 3 and 4 directly under the applied load and was about -20 microstrains. Backwall strains decreased with increasing distance from the location of the axial loads. In load configurations 2 and 3, the backwall showed positive strain values.

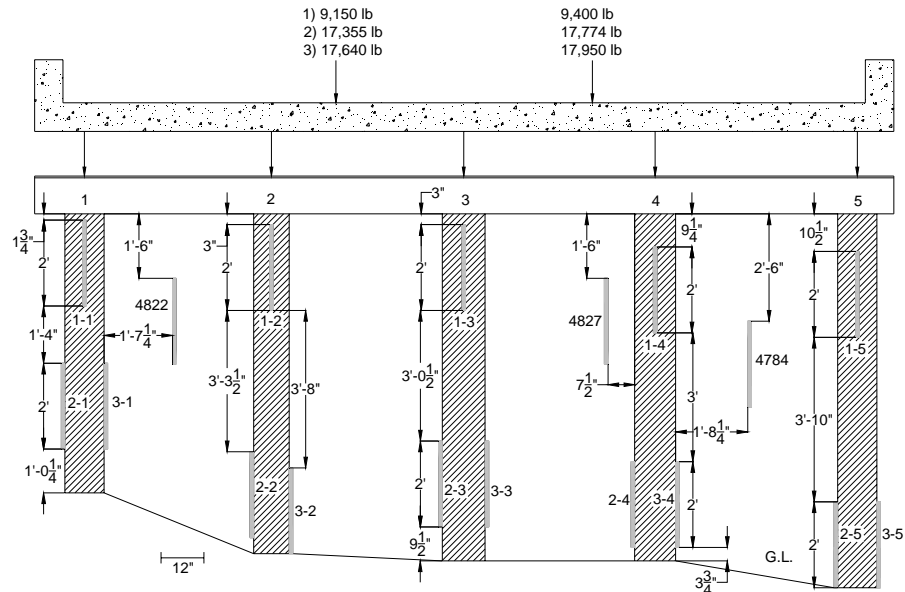
(a) Location of strain transducers and axial loads

The second load test was performed with the load at the centerline of the bridge deck. The location and magnitude of the applied axial loads, pile strains, and backwall strains are presented in Figure 9.17. The results indicate a more uniform strain distribution, compared to the west edge test, through the substructure components. The highest strain was measured in pile no. 2 and was about -29 microstrains in the third load configuration. Strain transducers 3-2 and 2-5 indicated higher strains since they were attached to softer pile sections. Backwall strains continued to show negative values in load configuration 1, and positive values in load configurations 2 and 3.

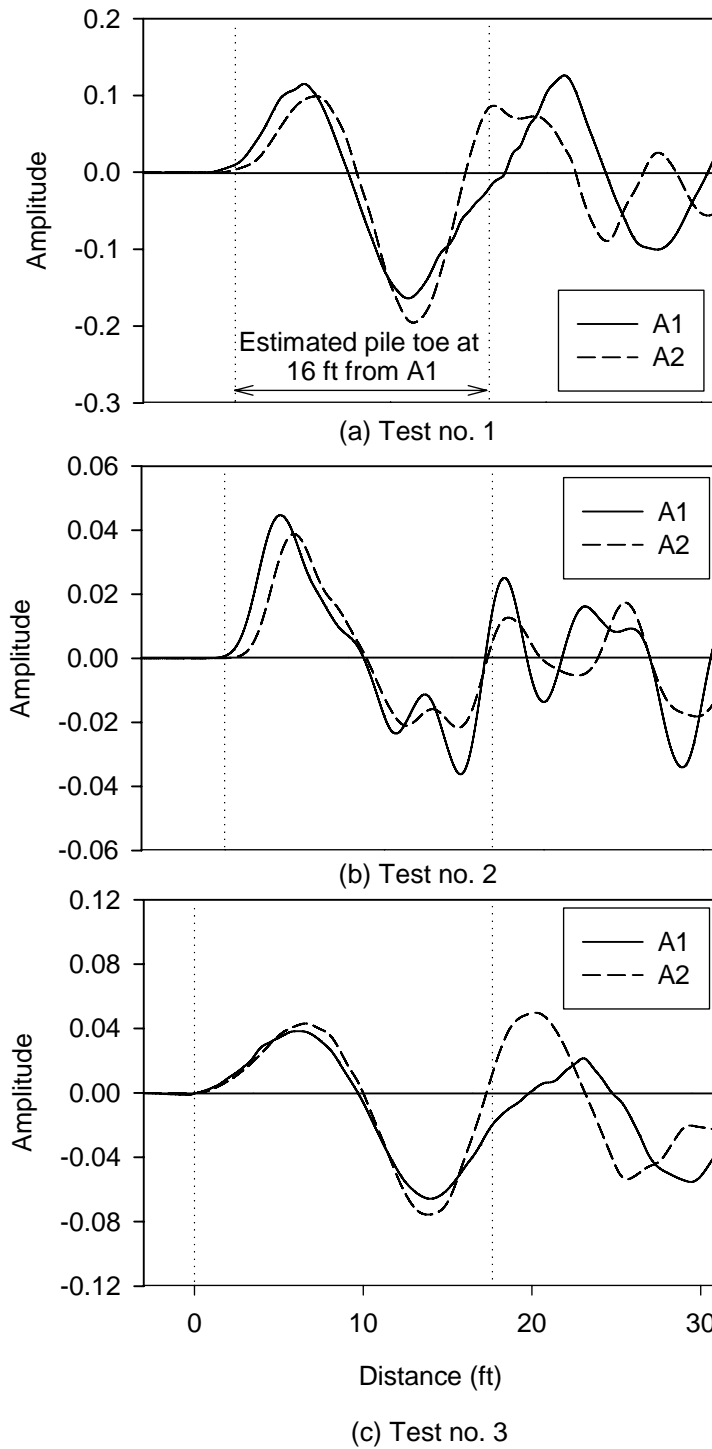
Abutment	Pile No.	Distance between A1 and A2 (ft)	Comments
North	2	2	Possible pile toe or defect at 21 ft (16 ft below A1 + 4.7 ft)
	2	5	
	3	3	Possible pile toe or defect at 20 ft (15 ft below A1 + 4.7 ft)
	3	2	
	3	5	
South	2	2	The defect at about 8 ft from the pile head makes the input pulse wide and prevents from seeing beyond this point
	2	4.5	
	3	2.5	The defect at about 7 ft from the pile head makes the input pulse wide and prevents from seeing beyond this point
	3	4.5	
	5	2	The defect at about 7 ft from the pile head makes the input pulse wide and prevents from seeing beyond this point
	5	5

Figure 9.26. Results of PIT on pile no. 2 at the north abutment (Bridge No. 237350 – Mahaska County)

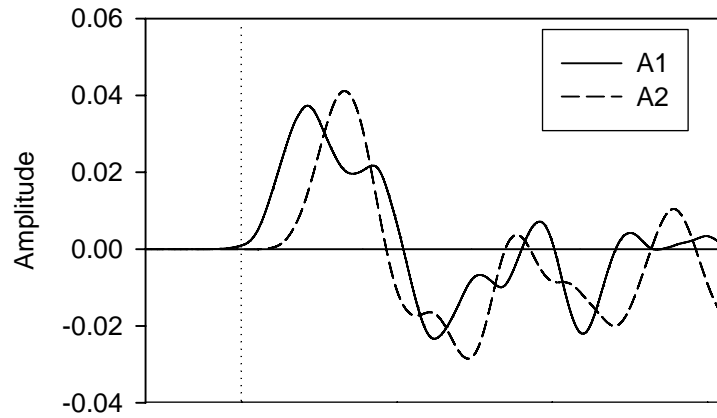
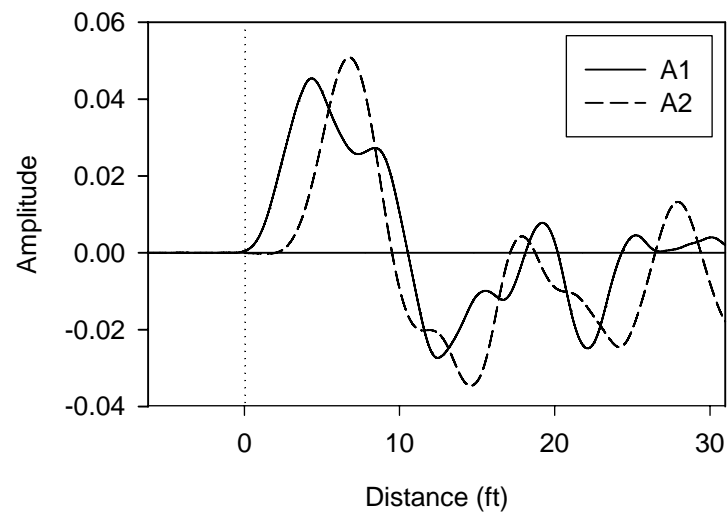
Figure 9.27. Results of PIT on pile no. 2 at the south abutment (Bridge No. 237350 – Mahaska County)

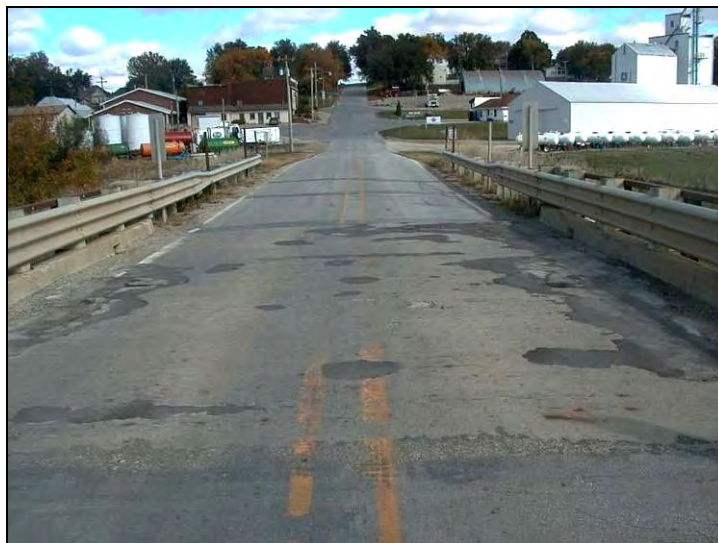
The fourth bridge tested was in Carroll County, Iowa. The bridge, which was 33.5 ft long, 22 ft wide, and has a 0° skew, was located on 245th St. south of Halbur, Iowa crossing a creek (See Figure 10.1). The superstructure consisted of a non-composite concrete deck supported by a four girder system. Due to deterioration in the concrete deck, as may be seen in Figure 10.2, there were numerous asphalt patches.

Figure 10.2. Concrete deck patched with asphalt (Bridge No. 094680 Carroll County – May 16 2006)

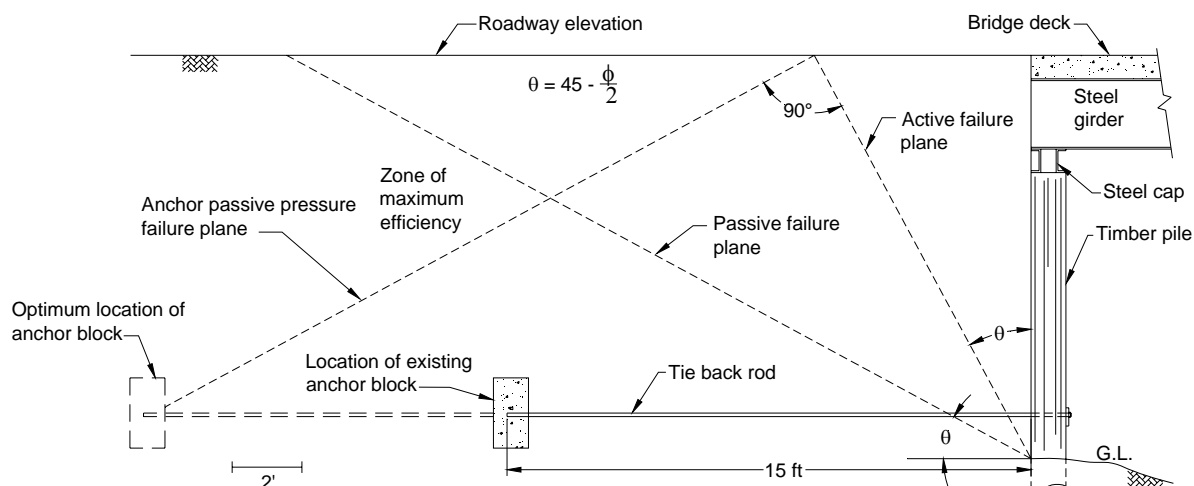
The bridge plans showed that the location of the anchor block was about 15 ft from the backwall and about 1.3 ft from the ground level. According to the design method proposed by Bowels (1996), the optimum location for the anchor block is in the zone of maximum efficiency, which would be located at 26 ft from the backwall at the current height (See Figure 10.10). The existing location, however, was still outside the active and passive failure zones.

Figure 10.10. Anchor block located outside the zone of maximum efficiency (Bridge No. 094680 – Carroll County)

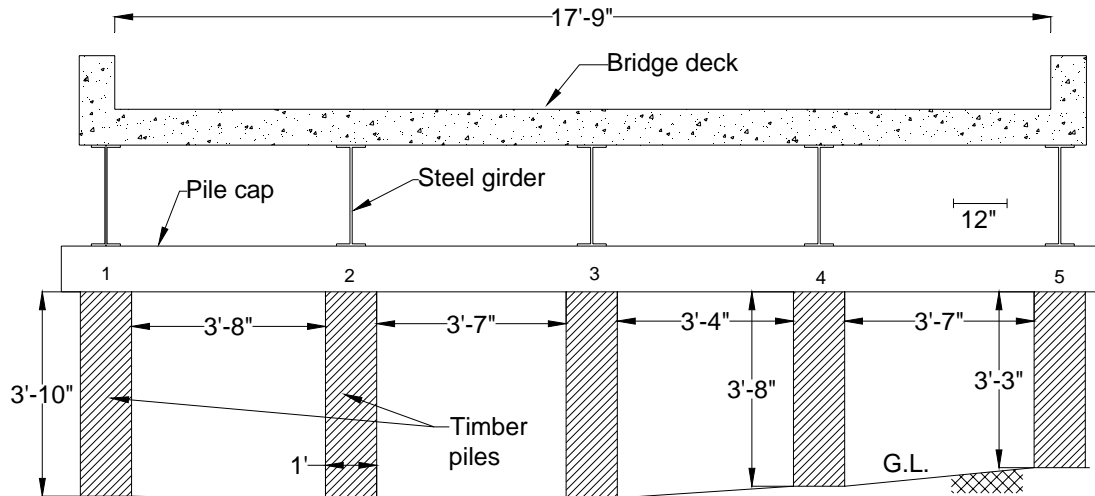
Figure 11.7. Schematic diagram of the southeast abutment (Bridge No. 237380 – Mahaska County)

Using the increment borer, pile cores were obtained from the piles both abutments. The density determined from each core and the elevation at which the cores were obtained are summarized in Table 11.1. Coring the piles revealed that pile nos. 2 and 4 at the southeast abutment are hollow near the pile core. It is estimated that the remaining intact diameters of pile nos. 2 and 4 are about 3 and 3.5 inches, respectively. As may be seen in Table 11.1, the wood density ranged from 35.8 lb/ft³ to 53.9 lb/ft³.

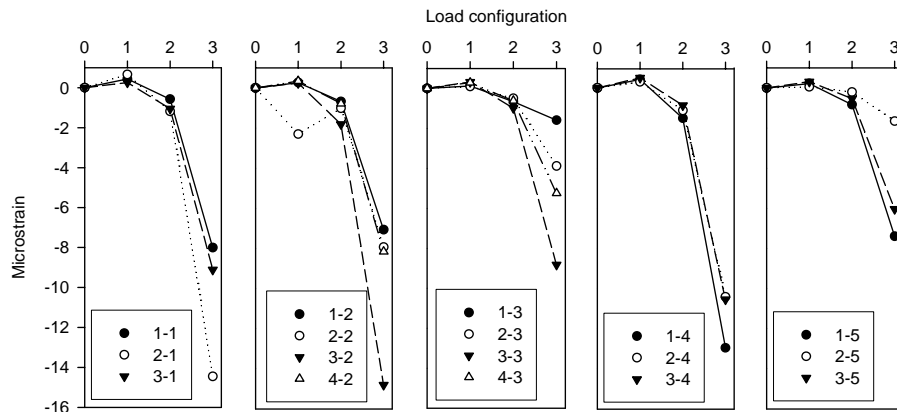
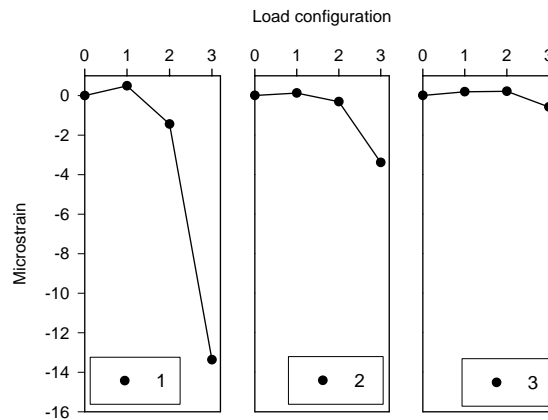
Figure 11.10. Static load test at the centerline (Bridge No. 237380 – Mahaska County)

The test was repeated with the loading at the centerline of the bridge. The location of the applied loads, pile strains, and backwall strains are shown in Figure 11.10. The results indicate that pile nos. 1, 2, and 4 are carrying most of the load since they displayed the highest strain measurement. The strain measured in pile no. 3 was about -9 microstrains similar to the previous test. This confirms the visual observation that the pile was deteriorated. Pile nos. 1 and 2 experienced similar strains even though pile no. 1 is further away from the location of the applied axial loads. The strains measured in pile nos. 1 and 2 were about -14 microstrains. This demonstrates that part of the load carried by pile no. 2 was transferred to adjacent pile no. 1. Similar to the previous test, backwall strains were highest at high elevation close to the applied load and decreased with increasing depth.

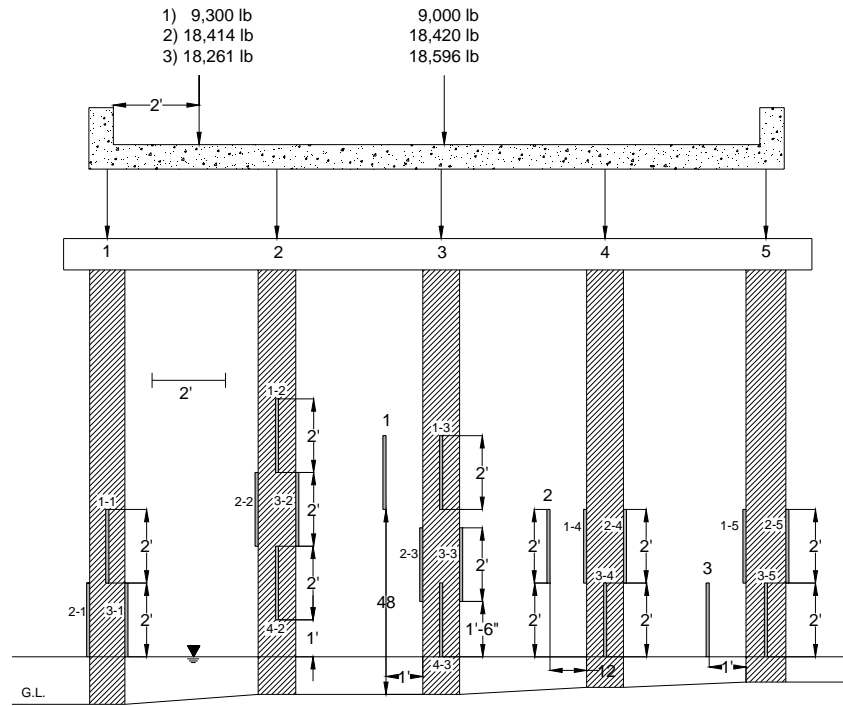
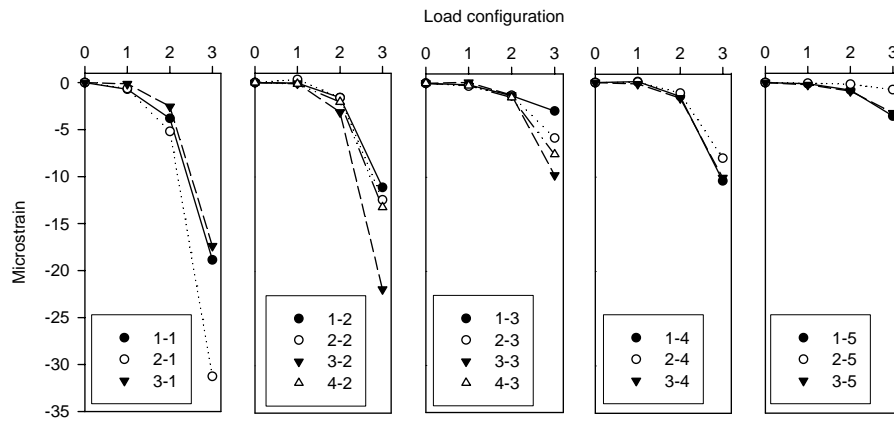
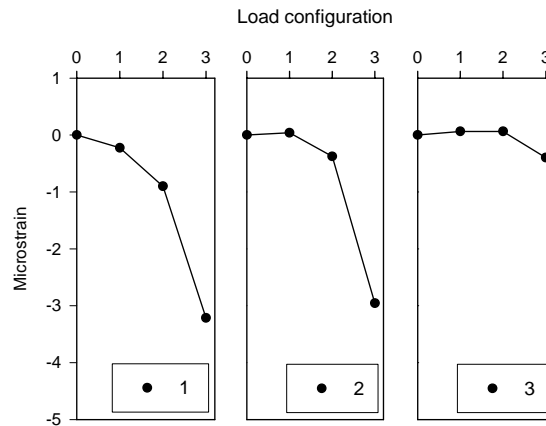
Figure 11.11. Static load test at the south edge (Bridge No. 237380 – Mahaska County)

The northwest abutment was tested with the loading at the south edge of the bridge. The location of the applied loads, which were offset 2 ft from the curb, pile strains, and backwall strains are shown in Figure 11.11. As shown in Figure 11.11a, one wheel load was directly above pile no. 3. However, the strains did not increase compared to the previous two tests. The highest strain value measured in load configuration 3 was still about -8 microstrains (See Figure 11.11b). The results also demonstrate that the load was mostly carried by pile no. 1 as evidenced by the higher strain.

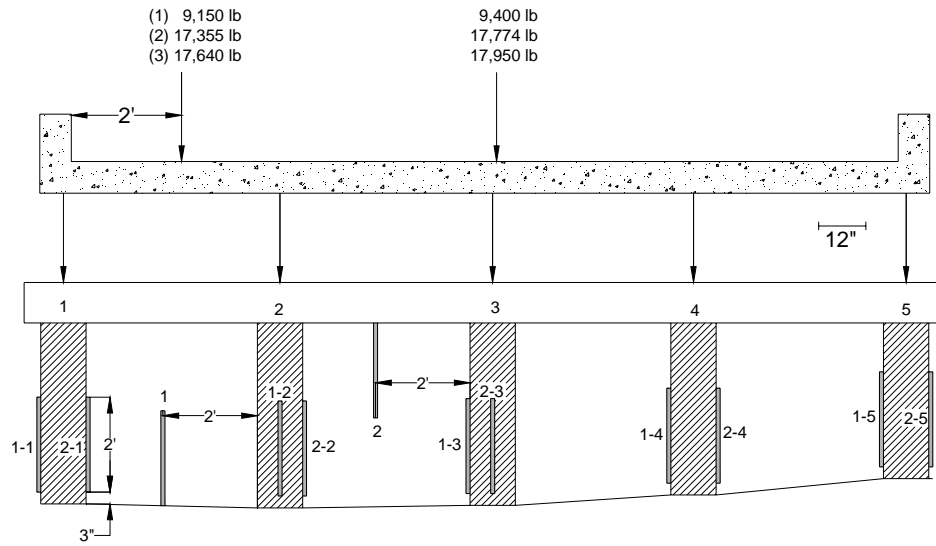
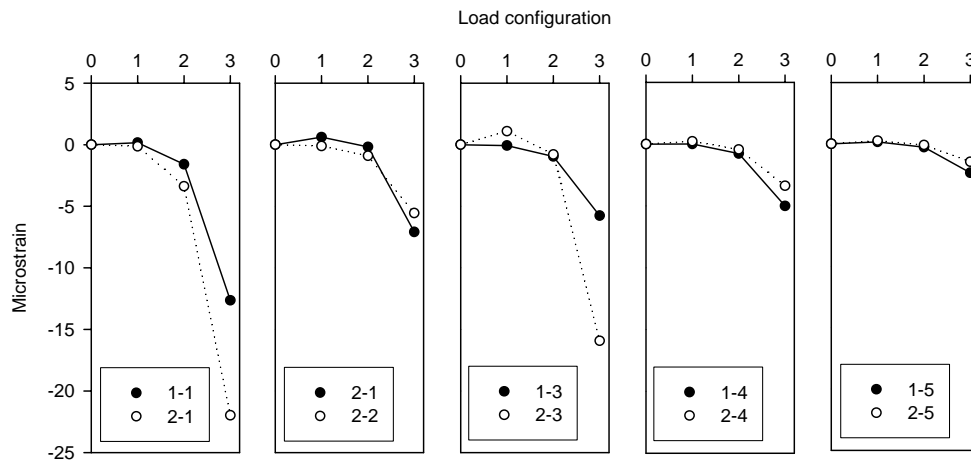
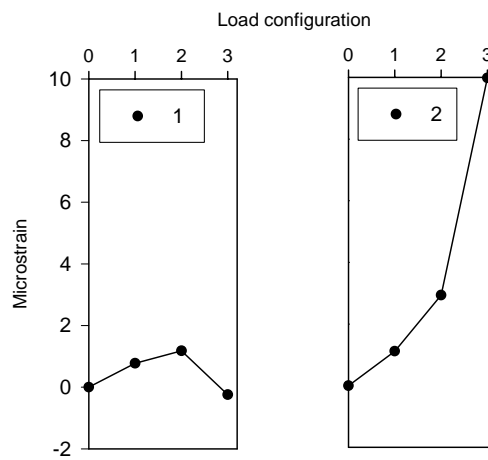
Figure 11.12. Static load test at the north edge (Bridge No. 237380 – Mahaska County)

The southeast abutment was first loaded with the loading positioned at the north edge of the bridge. Locations of the applied loads, pile strains, and backwall strains are presented in Figure 11.12. The results indicate that pile nos. 1 and 3 are carrying most of the load due to their higher strains. The strain decreased with increasing distance from the applied load.

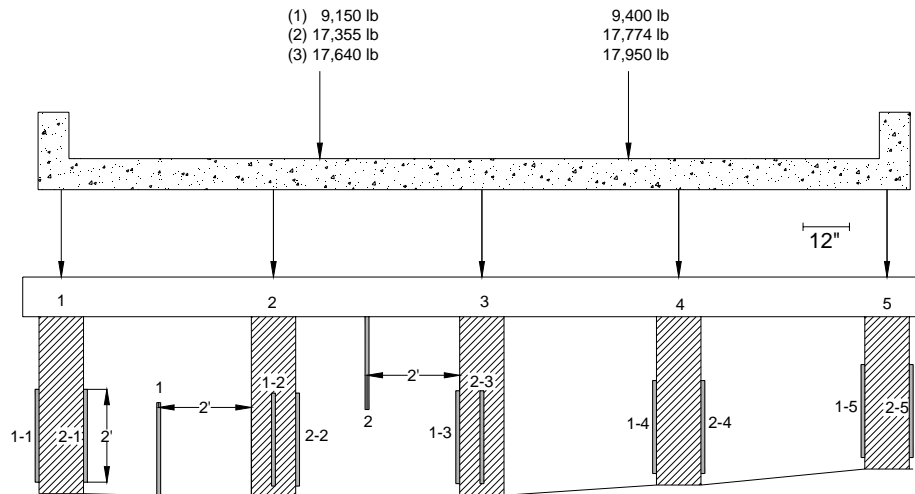
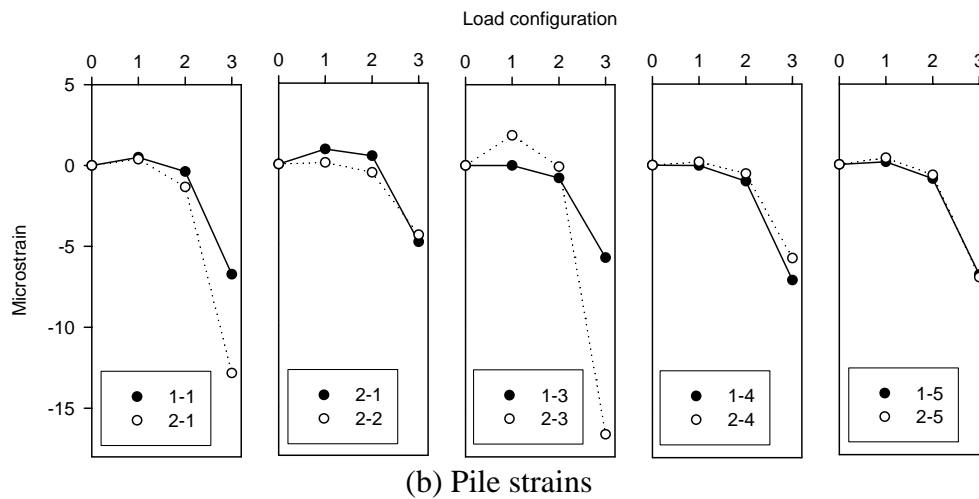
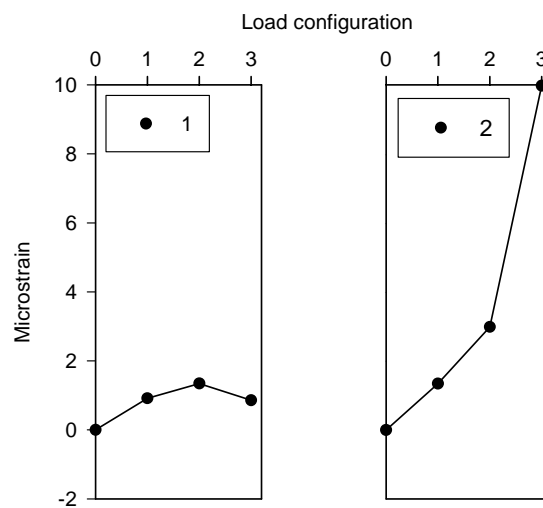
Figure 11.13. Static load test at the centerline (Bridge No. 237380 – Mahaska County)

When the loading was applied at the centerline of the bridge deck, the load was carried primarily by pile nos. 1 and 3 (See Figure 11.13). The strain measured in pile nos. 1 and 3 in load configuration 3 were -13 and -17 microstrains, respectively. Lower strain measurements were recorded at pile no. 2 during the centerline and north edge load tests.

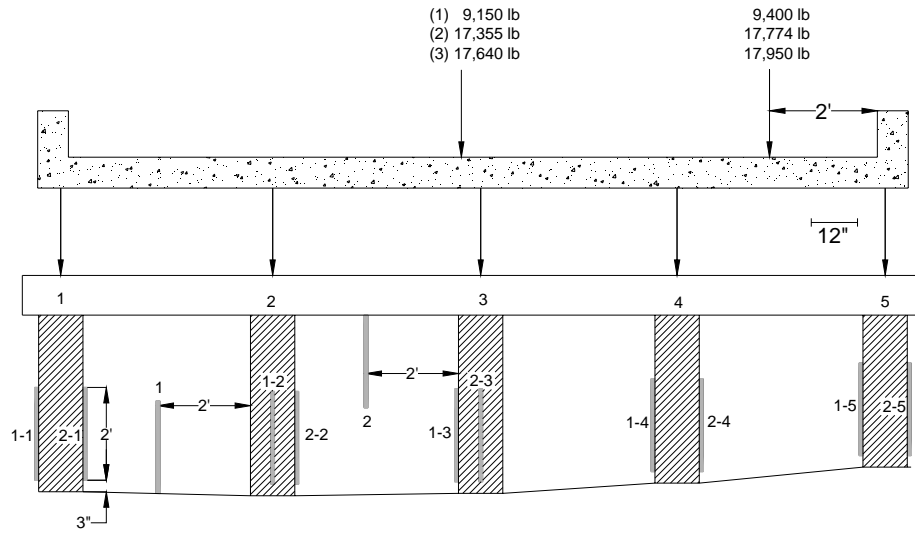
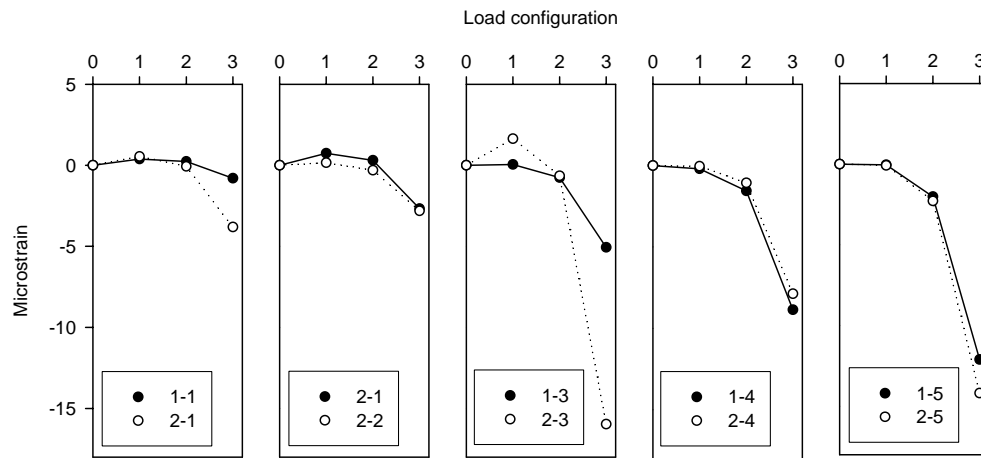
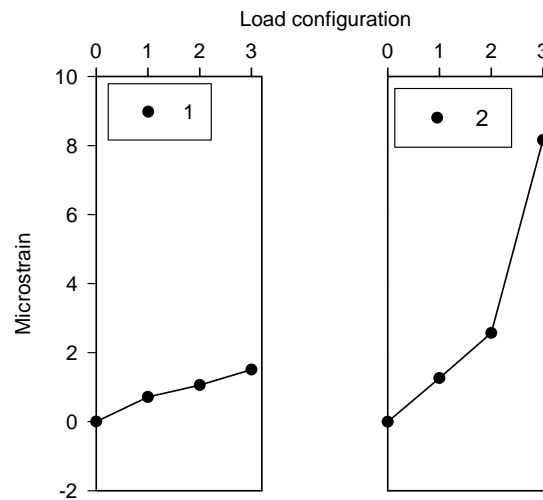
Figure 11.14. Static load test at the south edge (Bridge No. 237380 – Mahaska County)

In the third test at the south east abutment, loading was applied at the south edge of the bridge. Locations of the applied loads, pile strains, and backwall strains are presented in Figure 11.14. Pile nos. 3 and 5 experienced the highest strains. The strains measured at pile nos. 3 and 5 are -15.9 and -14.1, respectively. The strains decreased with increasing distance from the applied load.

The backwall strains in all tests were positive indicating tension or bending of the backwall away from the bridge abutment. This may be due to eccentric loading caused by the partial bearing of the pile cap on the backwall as shown in Figure 11.15.

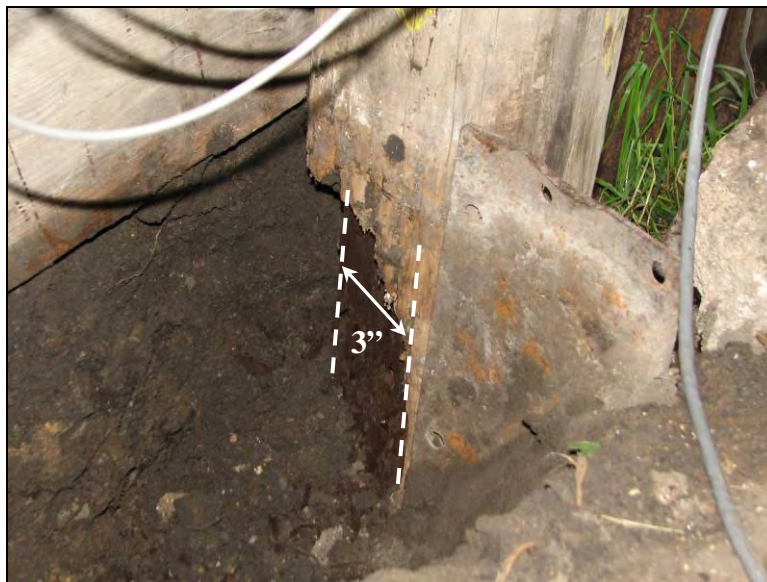
Figure 12.9. Advanced section loss at pile No. 6 at the east abutment (Bridge No. 029070 Humboldt County – July 12 2006)

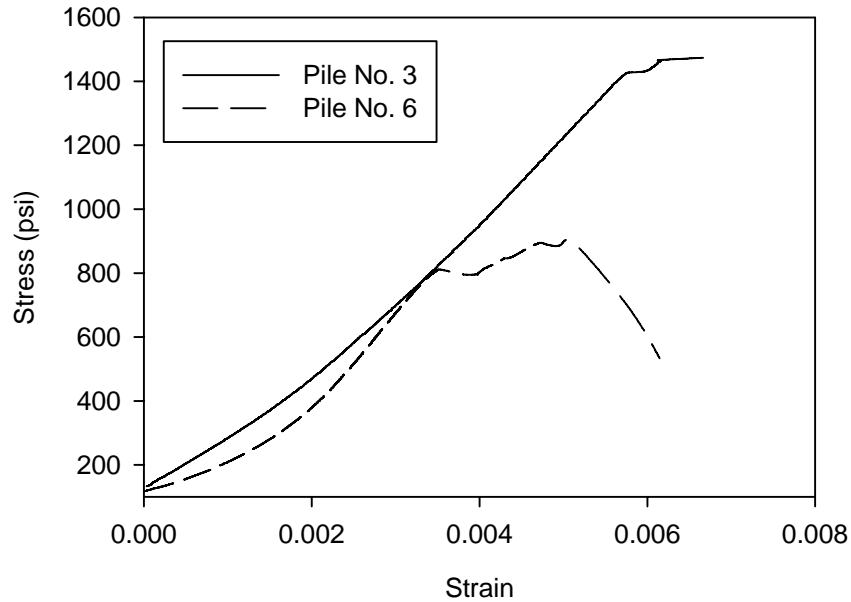
Figure 12.14. Stress-strain curves for pile Nos. 3 and 6 at the west abutment (Bridge No. 029070 – Humboldt County)

Upon completion of the load testing, the bridge was removed and replaced with a new box culvert (See Figure 12.12 and Figure 12.13). The exposed portion of pile nos. 3 and 6 in the west abutment were retrieved and tested in axial compression to determine their E values. E values of pile nos. 3 and 6 at the west abutment were 2.42×10^5 psi and 3.14×10^5 psi, respectively (See Figure 12.14).

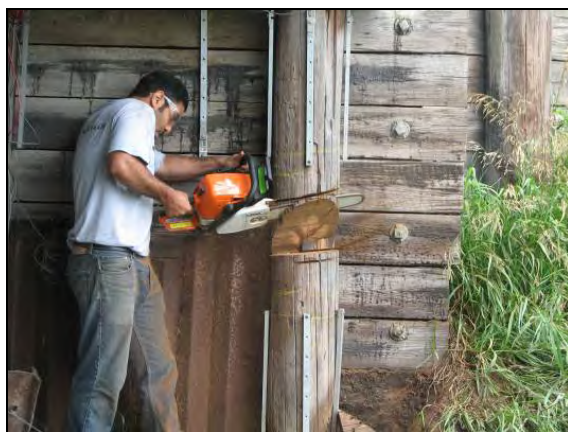
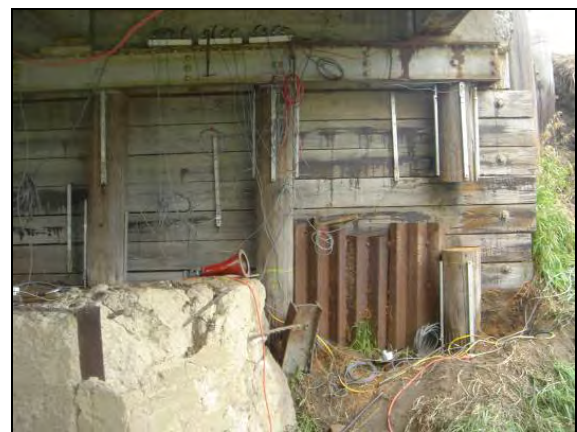
Figure 12.17. Destructive static load test (Bridge No. 029070 Humboldt County – July 12 2006)

The destructive load test was carried out at the east abutment by consecutively removing a 16 inch section from three of the seven supporting piles to simulate pile deterioration (See Figure 12.17). Pile nos. 7, 3, and 6 were removed consecutively. After removing each pile, the bridge was load tested and strains in the intact piles were measured. The east abutment with pile nos. 3 and 7 removed is shown in Figure 12.18. To measure the load carried by the removed piles, a load cell and a mechanical jack were installed as shown in Figure 12.19. Before statically loading the abutment, the mechanical jack was used to apply load on the pile. The load was gradually increased in order to restore the dead load, which was initially carried by the pile before removing the section. This was accomplished by monitoring the pile strain before and after removing the pile section and restoring the pile strain to its initial value. Once the initial strain was restored, the load carried by the pile was recorded using a readout attached to the load cell. This procedure was carried out for pile nos. 3 and 7. The section from Pile no. 6 that was removed near the ground level was not restored (See Figure 12.20).

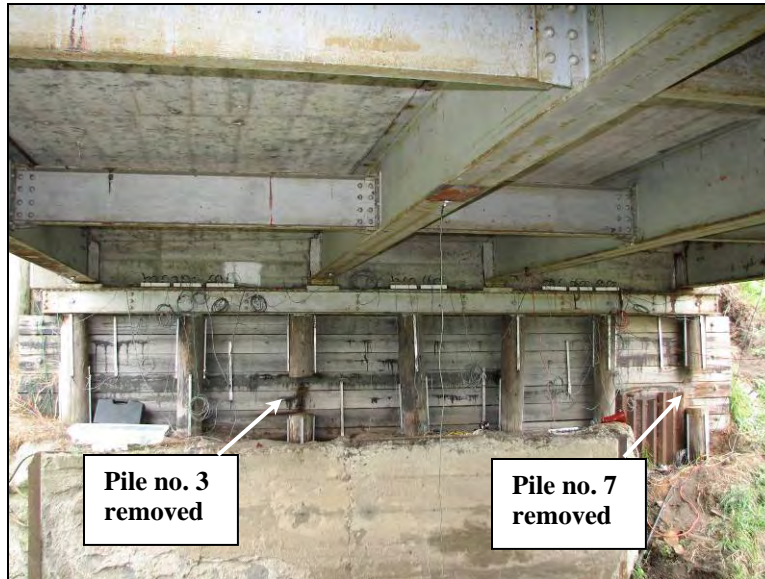
Figure 12.18. Pile nos. 3 and 7 removed at the east abutment (Bridge No. 029070 Humboldt County – July 12 2006)

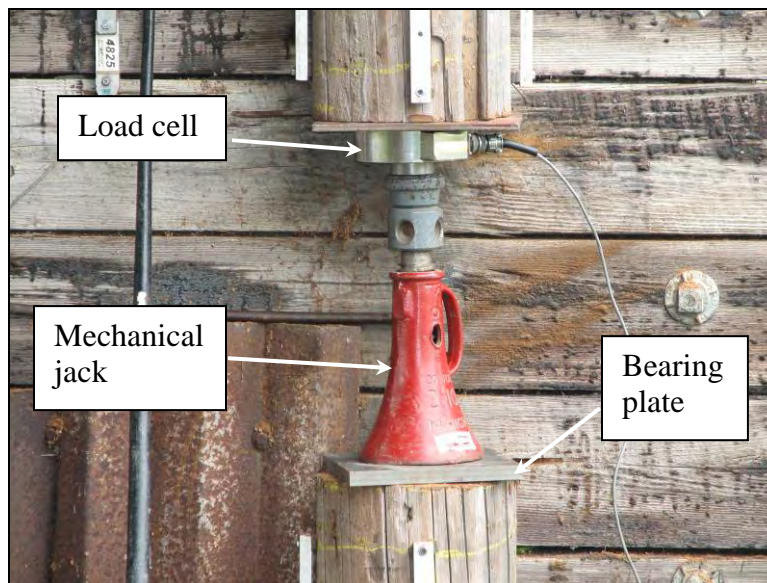
Figure 12.19. Mechanical jack and load cell used to restore and record the load carried by pile no. 7 (Bridge No. 029070 Humboldt County – July 12 2006)

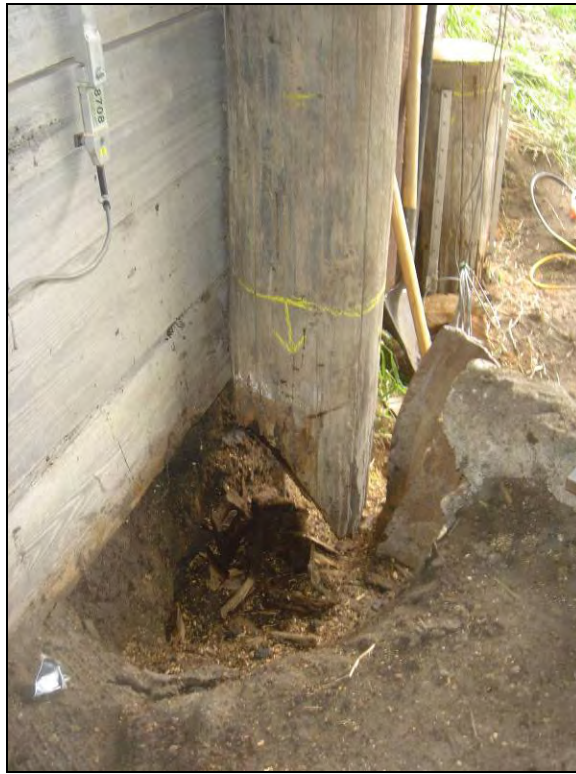
Figure 12.20. A section of Pile no. 6 removed near the ground level (Bridge No. 029070 Humboldt County – July 12 2006)

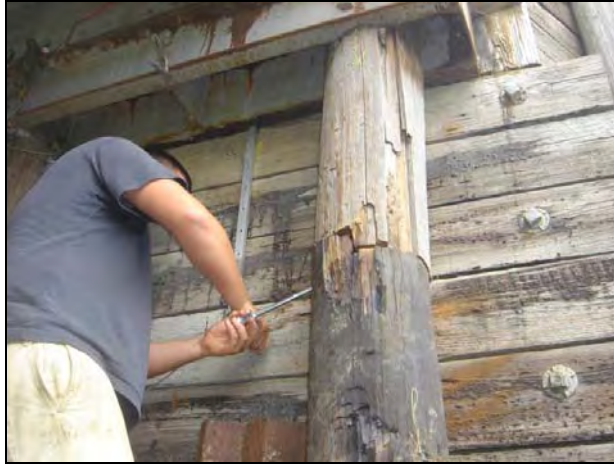
Figure 12.22. Metal screws used to connect the new section to the existing timber pile (Bridge No. 029070 Humboldt County – July 12 2006)

To determine the feasibility of repairing localized deteriorated sections in timber piles, pile no. 7 was repaired using a splicing technique in which the percent restoration of pile capacity was measured. A new timber section was spliced and placed instead of the removed section as shown in Figure 12.21. The existing and new pile sections were connected by installing two metal screws at an angle as demonstrated in Figure 12.22. Once repaired, the bridge was load tested and the percentage of the restored capacity was evaluated.

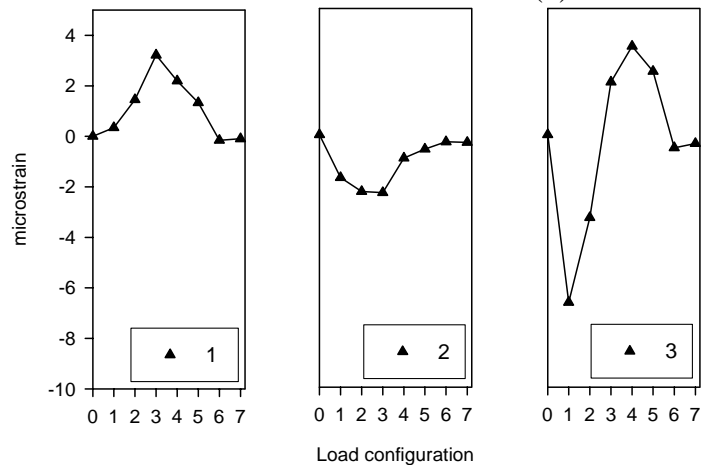
(c) Backwall strains

The west abutment was initially loaded at the west edge (see Figure 12.15 and Figure 12.23). The axial loads were offset 2 ft from the curb. The location of the axial loads, pile strain measurements and backwall strains are shown in Figure 12.23. Strain was highest directly under the applied load and decreased with distance from the location of the load. The highest strain measured, which was about -37 microstrains, was in pile no. 6 in load configuration 2. The results demonstrate the flexibility of the pile cap since the pile strains were not equal. Positive strains were observed in pile no. 1 and in the backwall between pile nos. 1 and 2.

Figure 12.23. Static load test at the north edge of the west abutment (Bridge No. 029070 – Humboldt County)
